DEPARTMENT OF TRANSPORTATION**DIVISION OF ENGINEERING SERVICES**

Contract #: 04-0120F4Cty: SF/ALA Rte: 80 PM: 13.2/13.9File #: 69.28**WELDING INSPECTION REPORT****Resident Engineer:**Siegenthaler, Peter**Address:** 333 Burma Road**City:** Oakland, CA 94607**Report No:** WIR-018174**Date Inspected:** 11-Nov-2010**Project Name:** SAS Superstructure**OSM Arrival Time:** 700**Prime Contractor:** American Bridge/Fluor Enterprises, a JV**OSM Departure Time:** 1900**Contractor:** Zhenhua Port Machinery Company, Ltd (ZPMC), Changxing Island **Location:** Shanghai, China**CWI Name:** Xu Xian Ping**CWI Present:** Yes No**Inspected CWI report:** Yes No N/A**Rod Oven in Use:** Yes No N/A**Electrode to specification:** Yes No N/A**Weld Procedures Followed:** Yes No N/A**Qualified Welders:** Yes No N/A**Verified Joint Fit-up:** Yes No N/A**Approved Drawings:** Yes No N/A**Approved WPS:** Yes No N/A**Delayed / Cancelled:** Yes No N/A**Bridge No:** 34-0006**Component:** Orthotropic Box Girder (OBG)**Summary of Items Observed:**

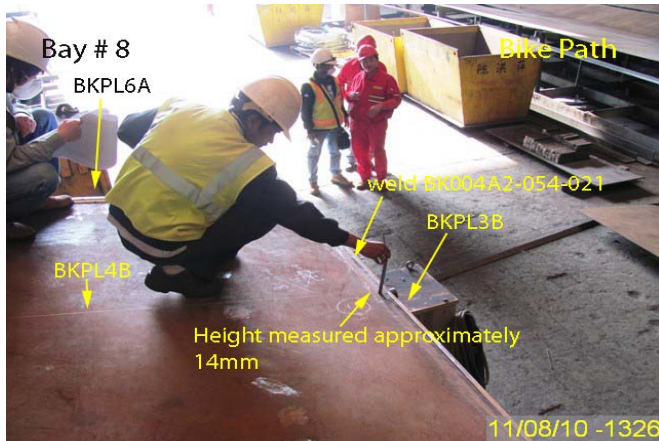
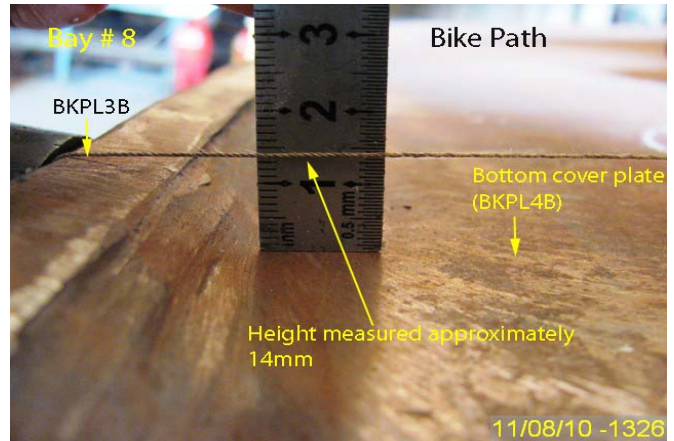
OBG # BAY 8

During the Caltrans Quality Assurance in-process observations of the fabrication of Bike Path, this Quality Assurance Inspector (QA) discovered the following issues. The Bottom Cover Plate (BKPL4B) is welded on the wrong location. According to the shop drawings BK4E, the bottom plate shall be welded 20mm below the Side Plate BKPL3B. The height of the side plate was measured approximately 14mm in 1000mm of length starting from Bottom Cover Diaphragm BKPL6A. CT QA Inspector previously observed ZPMC personnel used a steel backing bar at the same location. Reference NCR#ZPMC-0846 for additional information. The affected weld is BK4A2-054-021 joining bottom cover plate BKPL4B to the side plate BKPL3B. The Bike Paths is identified as BK004A-054. This QA notified ZPMC QC identified as Mr. Lui fa wen of this issue and that an incident report would be generated. For further information, please see the attached pictures below.
